Brenham ISD

Executive Summary

This document describes the results of a Facility Condition Assessment (FCA) and Engineering Best Practices Analysis of facilities owned and operated by the Brenham Independent School District (Brenham ISD, or the District).

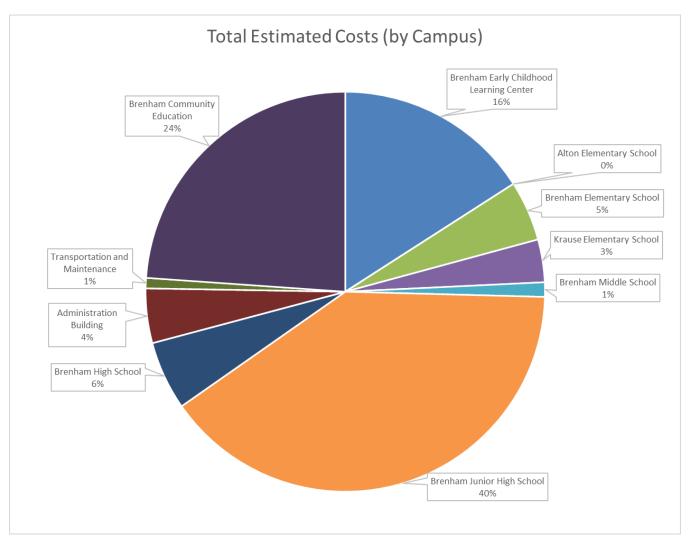
FIGURE 7: GRAPHIC BREAKDOWN OF TOTAL COST BY CAMPUS

Figure 6 and Figure 7 provide a summary of cost estimates by year based on campus.

The following tables and charts found in Figure 6 through Figure 11 present an overview of deficiencies summarized and presented by Campus Location, assessment Discipline, and the primary Building Use.

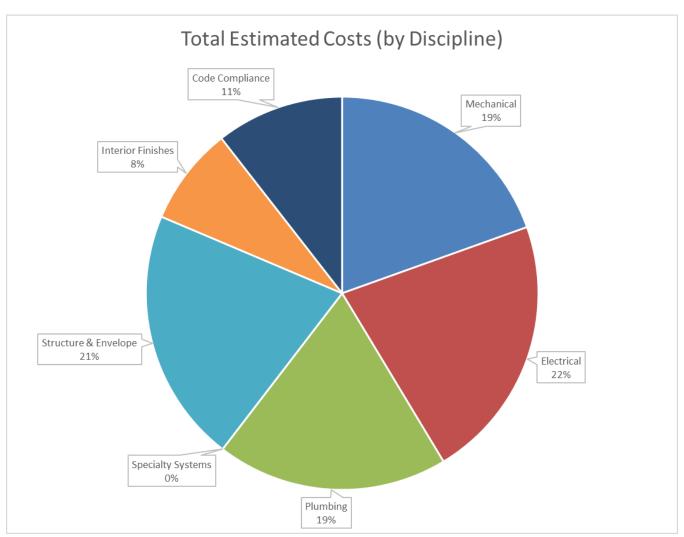
FIGURE 9: GRAPHIC BREAKDOWN OF TOTAL COST BY DISCIPLINE

Figure 8 and Figure 9 provide a summary of cost estimates by year based on assessment discipline.

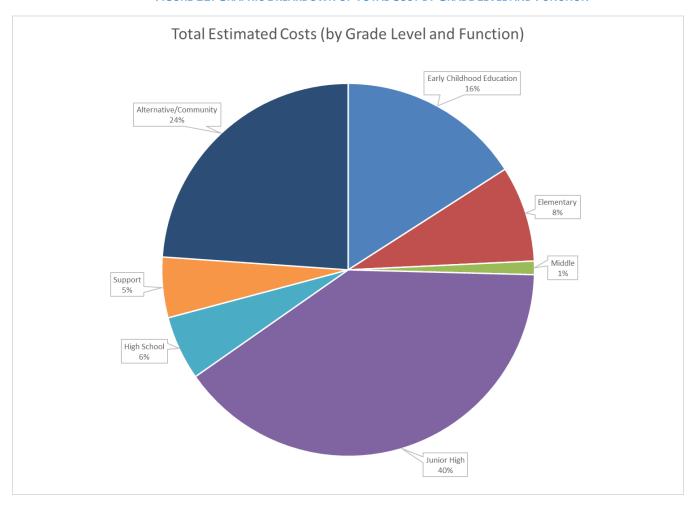
FIGURE 11: GRAPHIC BREAKDOWN OF TOTAL COST BY GRADE LEVEL AND FUNCTION

Figure 10 and Figure 11 provide cost estimates by year based on building use (by grade level and function).

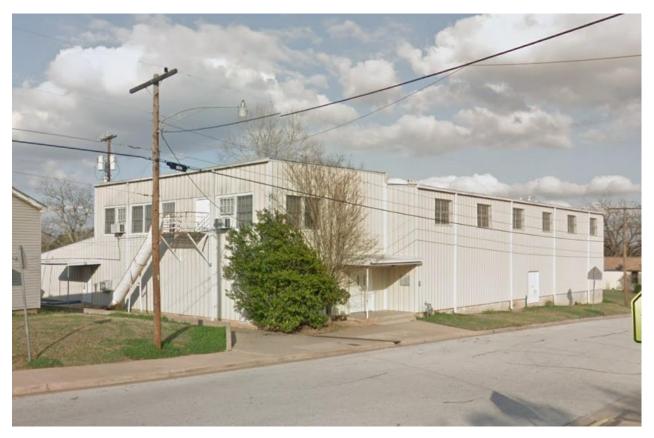
FIGURE 17: EXTERIOR VIEW OF GYMNASIUM

Exterior wall panels are in poor condition - evidence of numerous leaks observed.

Glazed openings are in poor condition; leaks observed.

Roof is in poor condition; evidence of numerous leaks observed.
